Distal Radius Plates: Why Stronger Is Not Always Better

A. Spiegel, PhD, Medartis AG, Switzerland

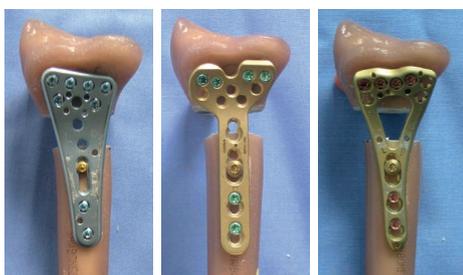
Figure 1: From left to right Medartis, Competitor 1 and 2 (mounted on Sawbones)

Three different types of volar locking systems for distal radius fractures were used (Figure 1):

- Medartis: APTUS Radius 2.5, A-4750.17/.18, a variable angle system
- Competitor 1: A leading fixed angle system
- Competitor 2: A leading variable angle system

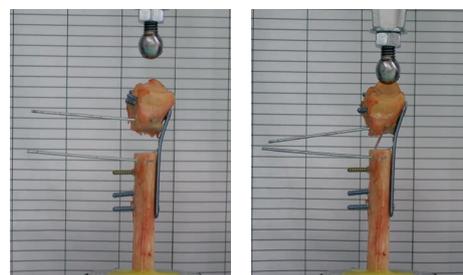
Figure 2: Test setup; left: before, right: after test

Testing was carried out at the Ludwig Boltzmann Institute for Experimental and Clinical Traumatology in Vienna using a MTS universal testing machine. Samples were loaded to 400 N for 2000 cycles [3] or until failure (mechanical failure or screw cut-out through the articular surface). Load and displacement were recorded at the point of load transfer. Radial shortening (residual deformation after unloading) as well as radial inclination and volar tilt were determined after testing using standardised photographs (Figure 2).

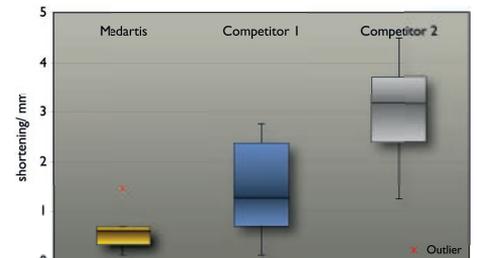
Figure 3: Radial Shortening at the end of the test

Figures 3 and 4 show radial shortening as well as radial inclination and volar tilt. The Medartis plate also has the smallest SLoR. Looking at the failure mechanisms observed it becomes apparent why: failure occurred either through the formation of significant longholes in the bone around the distal locking screws or through breakage of locking screws (Figure 5). Both failure mechanisms were observed with competitor plates only and not with the Medartis plate.

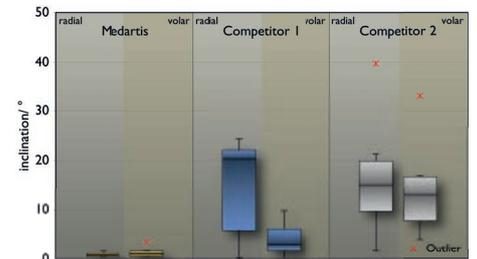
Figure 4: Radial inclination and volar tilt at the end of test

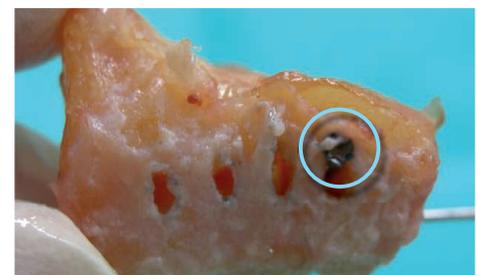
Figure 5: Distal fragment post test after removal of plate 3 showing 'long holes' and broken screw (blue circle)

It is generally believed that mechanically stronger osteosynthesis systems always perform better. However, in stiff systems all stresses must be absorbed by the bone-screw interface. The present tests illustrate that high stiffness and mechanical strength may turn out to be a disadvantage, especially in bone of poor quality. Due to the poor quality of osteoporotic bone and the non-physiologic properties of the implant, the bone's trabecular structure may be damaged by the repeated loading. While a single stress event would most likely not cause any problems, damage may accumulate over time leading to the formation of 'long holes' around the screws resulting ultimately in the penetration of the joint surface. This mechanism is well known from the proximal humerus but has also been described in the distal radius [4]. The long holes may lead to a loosening of the implant promoting screw fractures as observed in our tests (Figure 5).
